2023 Year End Report for CSTS Systems  
Monterey Heights/South Passage  
City of Credit River, Minnesota

Natural Systems Utilities (herein referred to as NSU) is providing wastewater operation and maintenance services for the South Passage and Monterey Heights wastewater treatment facilities. Attached is a summary of system performance, flow monitoring, interpretation of analytical results and a summary of anticipated future capital replacement and maintenance needs.

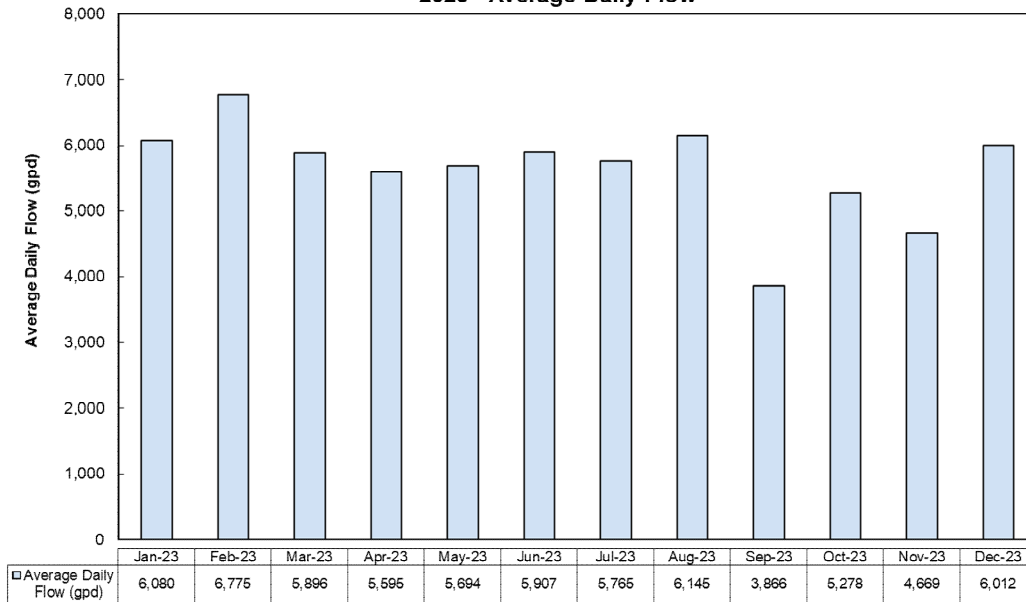
### Credit River - Monterey Heights 2023 - Average Daily Flow

NSU monitors the flows for both systems to ensure they are within the design parameters. The flows for 2023 were both within parameters and were reasonable for the number of homes that are currently connected to the system. South Passage continues to trend higher in flow per home than Monterey Heights. This may be due to iron filter settings, individual water fixture units installed, having a higher population per home on average, an unidentified source of inflow and infiltration, or another unidentified factor. Despite this, there are no current concerns with the flow numbers. Further, the flow numbers are very consistent with past years. Below is a summary of flows for 2023:

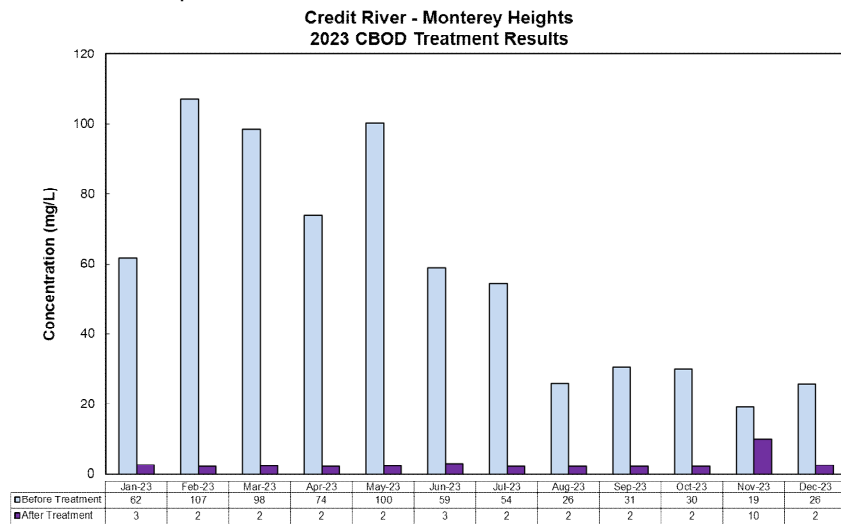
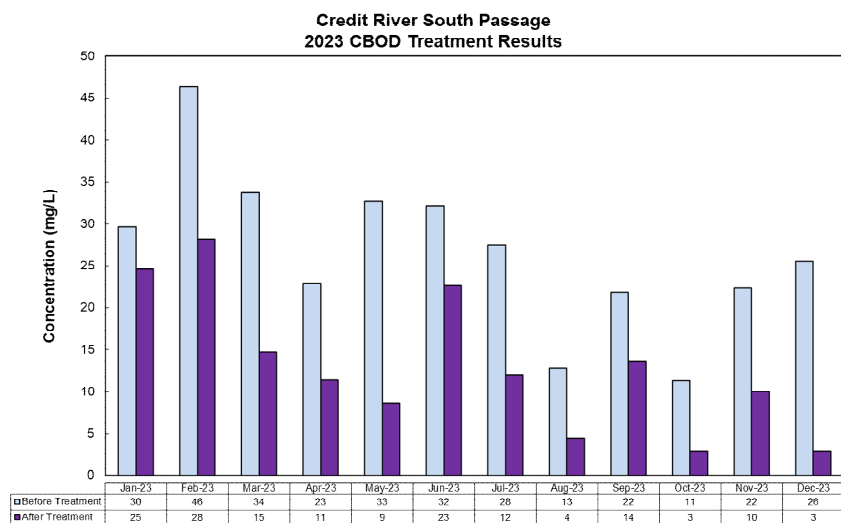
Routine analytical sampling is conducted twice per month as required by the MPCA permit. Overall treatment at the Monterey Heights facility was very good in 2023 with regard to carbonaceous biochemical oxygen demand (CBOD; organic strength) and total suspended solids (TSS). South Passage influent numbers were not accurately sampled January – September due to the influent pipe frequently below the water level of the tank in 2023. This was done to allow the gravel bed recirculation time to rest between doses and prevent surfacing of water in the wetlands. In October South Passage replaced the gravel filter with AdvanTex Pods. Both the facilities have groundwater monitoring wells to monitor the Total Nitrogen as well as chloride. Total nitrogen (TN) is measured as the sum of total Kjeldahl nitrogen (TKN) and nitrate plus nitrite (N+N). Charts of treatment performance are included below:

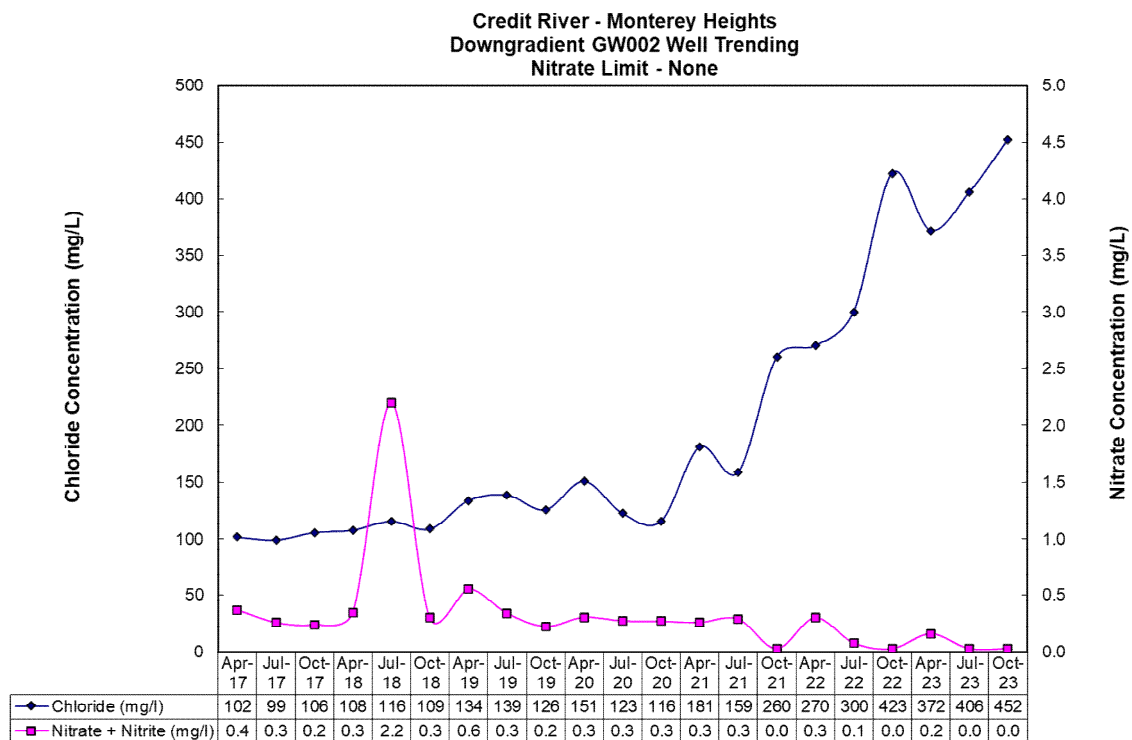
Performance of the wastewater system is monitored monthly influent and effluent sampling along with seven groundwater monitoring wells. Three wells monitor groundwater impacts at South Passage (GW005, GW006, GW007), and four wells monitor the system for Monterey Heights (GW002, GW004, GW009, GW010). The monitoring well data is consistent with results from previous years. Monitoring wells for both systems are within permit requirements.

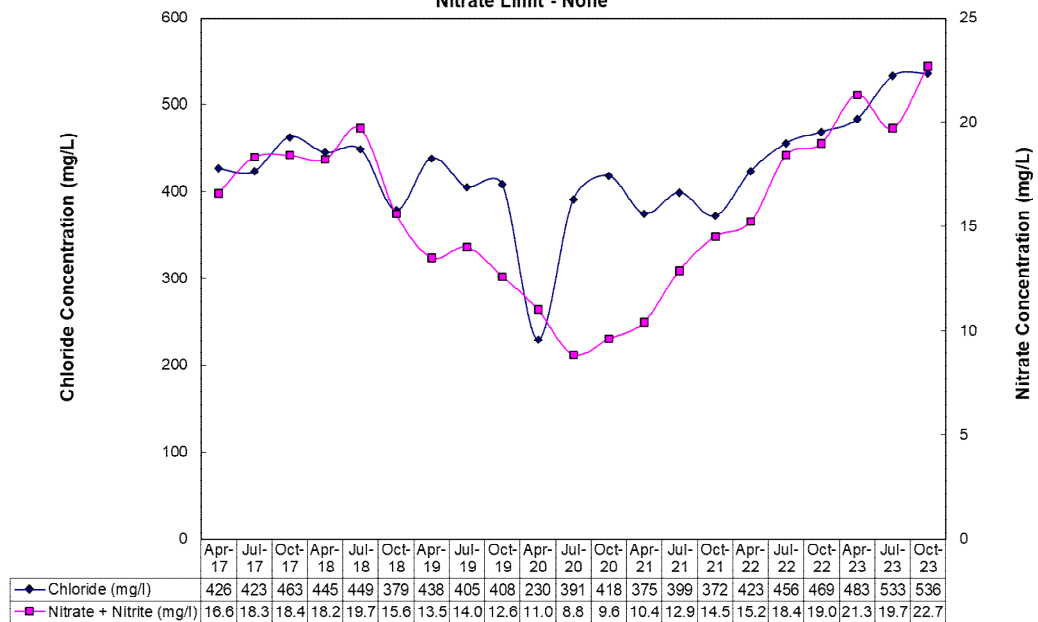
**Credit River South Passage  
Downgradient GW007 Well Trending  
Nitrate Limit - None**

One groundwater monitoring well in South Passage (GW007) is in close proximity to the WWTF and that continues to get significant hits of nitrates and chlorides. This was discussed with the Minnesota Pollution Control Agency during a fall 2008 Compliance Monitoring Survey and in subsequent meetings through 2010, and again in the spring of 2012. The MPCA concurred that the monitoring well is located too close to the existing wastewater disposal system. Graphs of monitoring well performance are shown below:
