2023 Year End Report for CSTS Systems  
Monterey Heights/South Passage  
City of Credit River, Minnesota

Natural Systems Utilities (herein referred to as NSU) is providing wastewater operation and maintenance services for the South Passage and Monterey Heights wastewater treatment facilities. Attached is a summary of system performance, flow monitoring, interpretation of analytical results and a summary of anticipated future capital replacement and maintenance needs.

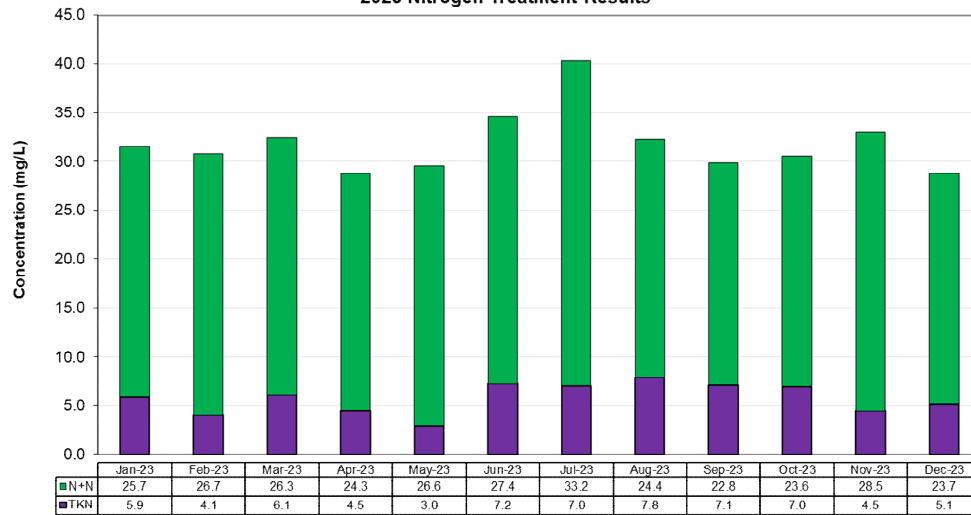
**Credit River - Monterey Heights  
2023 Nitrogen Treatment Results**

Routine analytical sampling is conducted twice per month as required by the MPCA permit. Overall treatment at the Monterey Heights facility was very good in 2023 with regard to carbonaceous biochemical oxygen demand (CBOD; organic strength) and total suspended solids (TSS). South Passage influent numbers were not accurately sampled January – September due to the influent pipe frequently below the water level of the tank in 2023. This was done to allow the gravel bed recirculation time to rest between doses and prevent surfacing of water in the wetlands. In October South Passage replaced the gravel filter with AdvanTex Pods. Both the facilities have groundwater monitoring wells to monitor the Total Nitrogen as well as chloride. Total nitrogen (TN) is measured as the sum of total Kjeldahl nitrogen (TKN) and nitrate plus nitrite (N+N). Charts of treatment performance are included below:

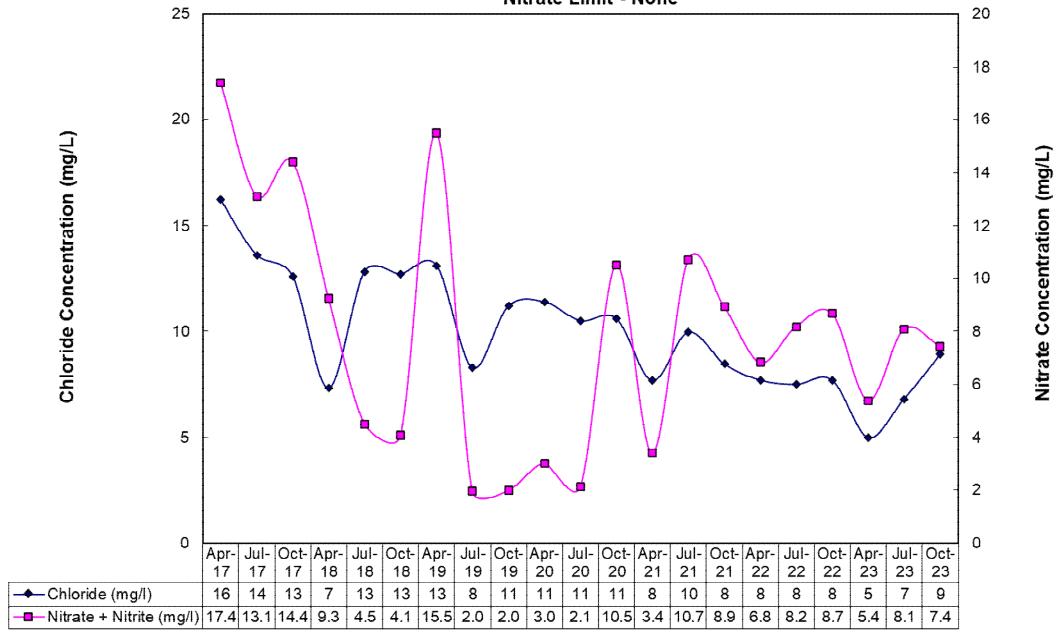
**Credit River - Monterey Heights  
Downgradient GW004 Well Trending  
Nitrate Limit - None**

Performance of the wastewater system is monitored monthly influent and effluent sampling along with seven groundwater monitoring wells. Three wells monitor groundwater impacts at South Passage (GW005, GW006, GW007), and four wells monitor the system for Monterey Heights (GW002, GW004, GW009, GW010). The monitoring well data is consistent with results from previous years. Monitoring wells for both systems are within permit requirements.
